## THE LEUCHTER REPORTS: CRITICAL EDITION

# THE LEUCHTER REPORTS

CRITICAL EDITION

## *The Leuchter Reports: Critical Edition*

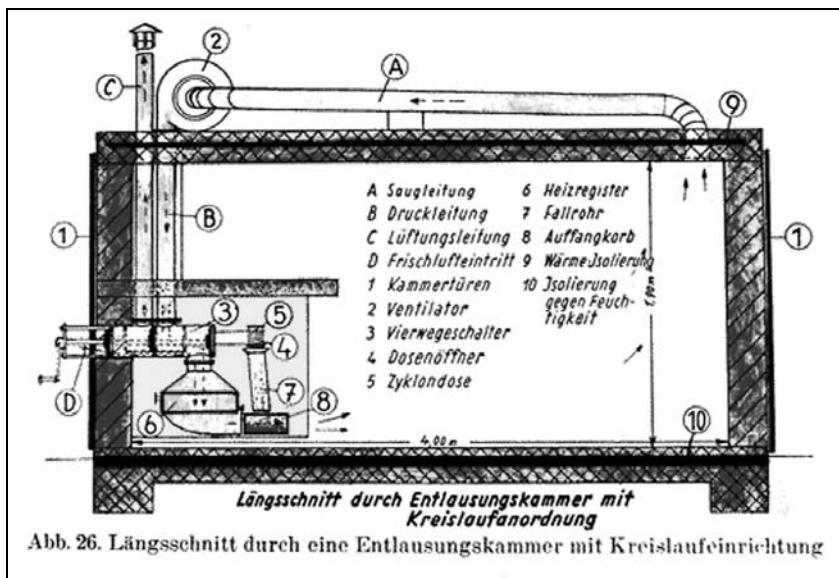
**Fig. 3: DEGESCH delousing chamber with circulation feature.**<sup>41</sup> This design was developed in the late 1930s / early 1940s and became a standard in Germany during the war. It was, however, not installed in all concentration camps, which were frequently equipped with makeshift delousing chambers. Editor's note.

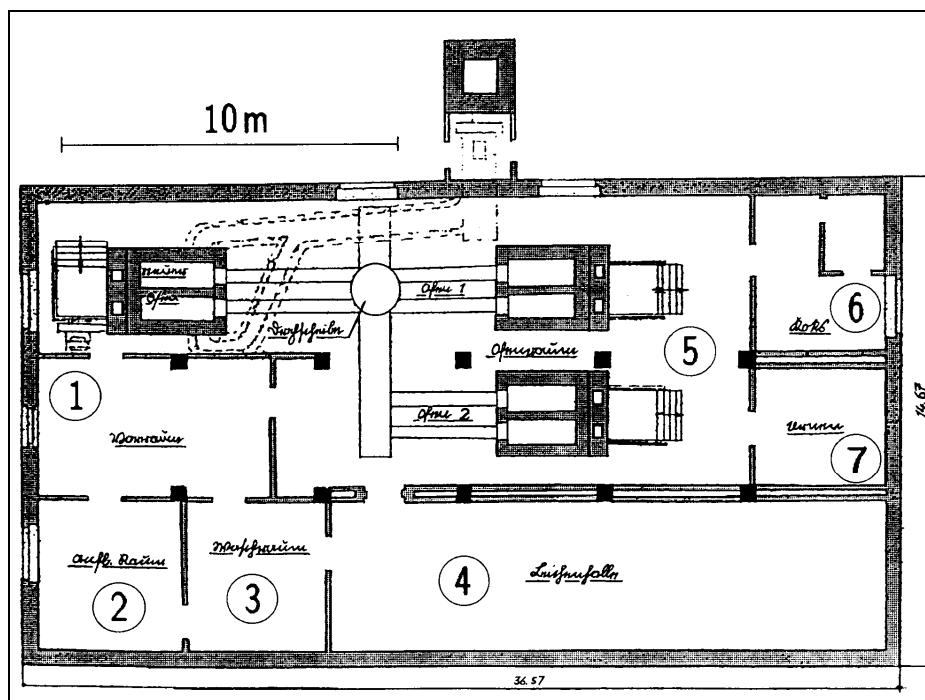
**Fig. 4:** Ground plan of crematorium I in Auschwitz I/main camp in its original condition. The morgue was later alleged to have been used as a 'gas chamber'.<sup>126</sup>

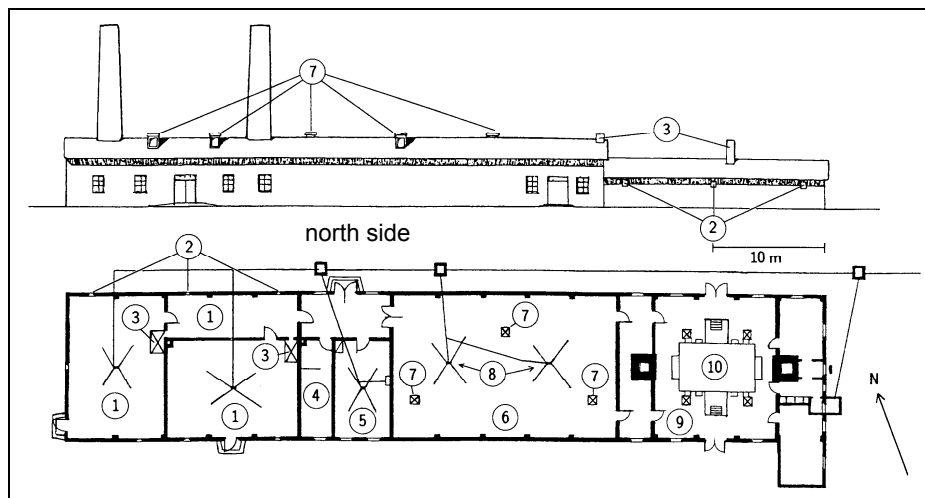
**Fig. 7:** North lateral view (above) and ground plan (below) of crematorium IV and/or V (mirror image) in Auschwitz II/Birkenau camp.<sup>146</sup>

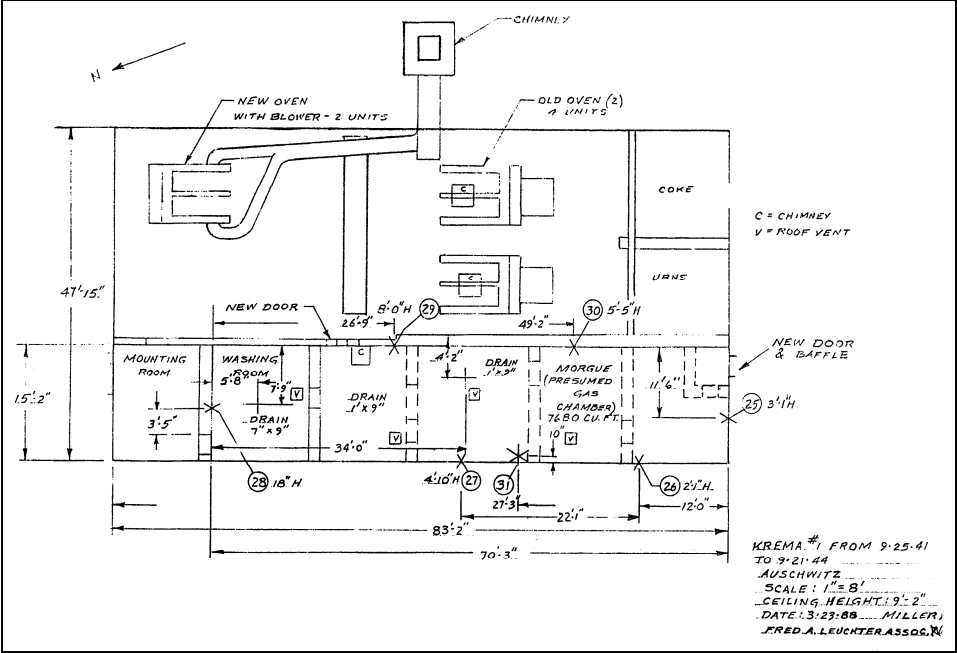
Fig. 12: Floor plan of Krematorium I in Auschwitz main camp, drawn by H. Miller, Fred A. Leuchter Associates. Numbers in circles denote locations where wall sample were taken.

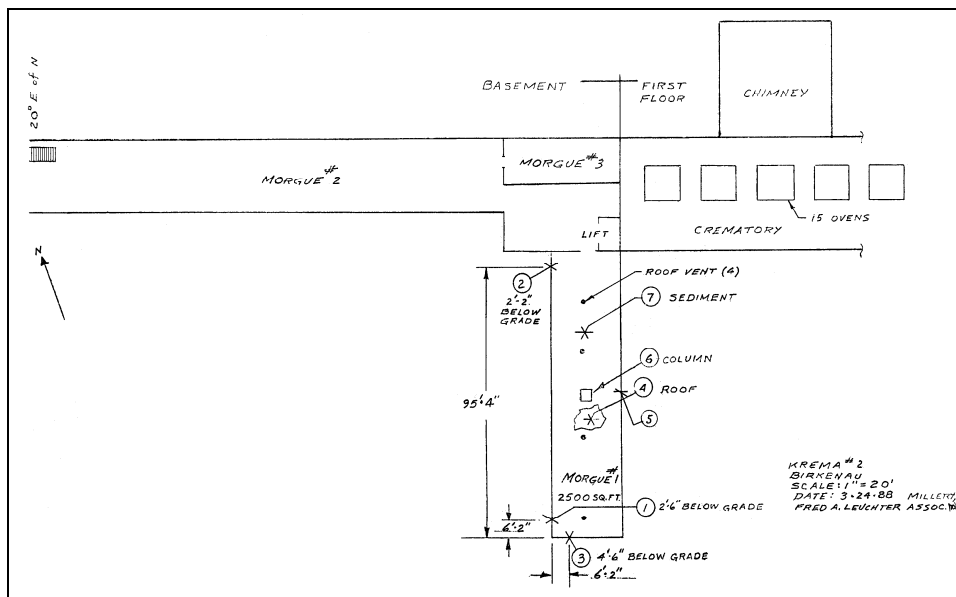
**Fig. 13:** Floor plan of Krematorium II in Auschwitz Birkenau, drawn by H. Miller, Fred A. Leuchter Associates. Numbers in circles denote locations where wall sample were taken. Note: The "Roof Vent (4)" do not exist; see document on next page.

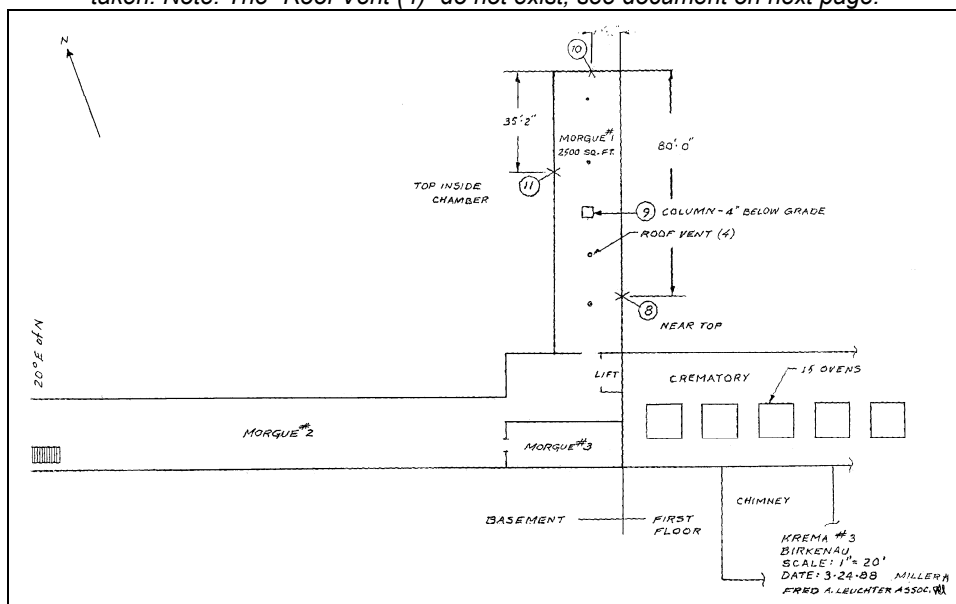
**Fig. 14:** Floor plan of Krematorium III in Auschwitz Birkenau, drawn by H. Miller, Fred A. Leuchter Associates. Numbers in circles denote locations where wall sample were taken. Note: The "Roof Vent (4)" do not exist; see document on next page.

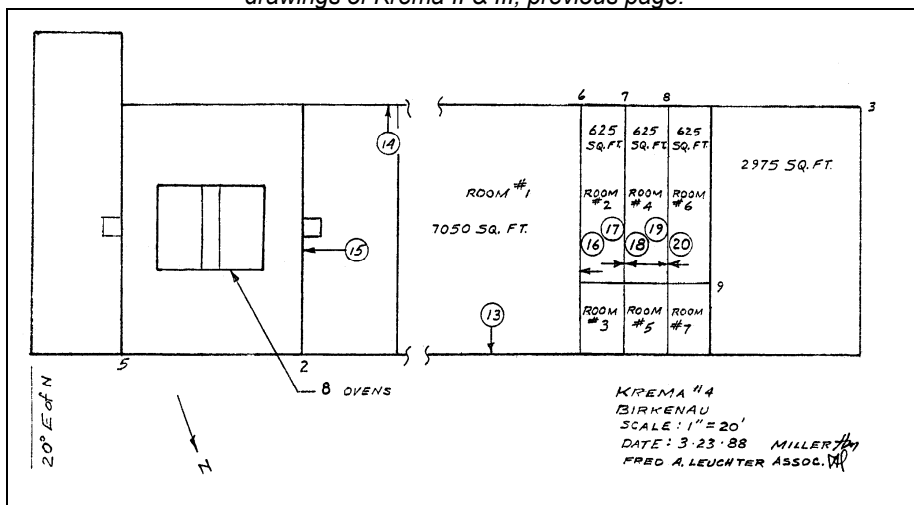
**Fig. 16:** Floor plan of Krematorium IV in Auschwitz Birkenau, drawn by H. Miller, Fred A. Leuchter Associates. Numbers in circles denote locations where wall sample were taken.

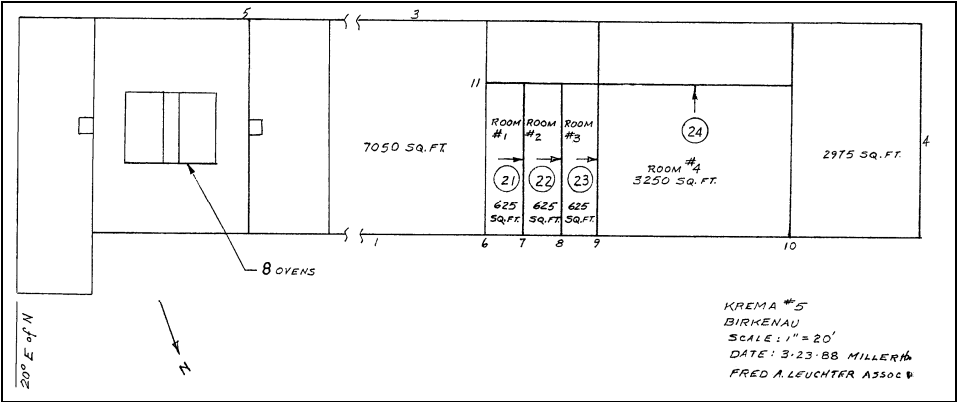
Fig. 17: Floor plan of Krematorium V in Auschwitz Birkenau, drawn by H. Miller, Fred A. Leuchter Associates. Numbers in circles denote locations where wall sample were taken.

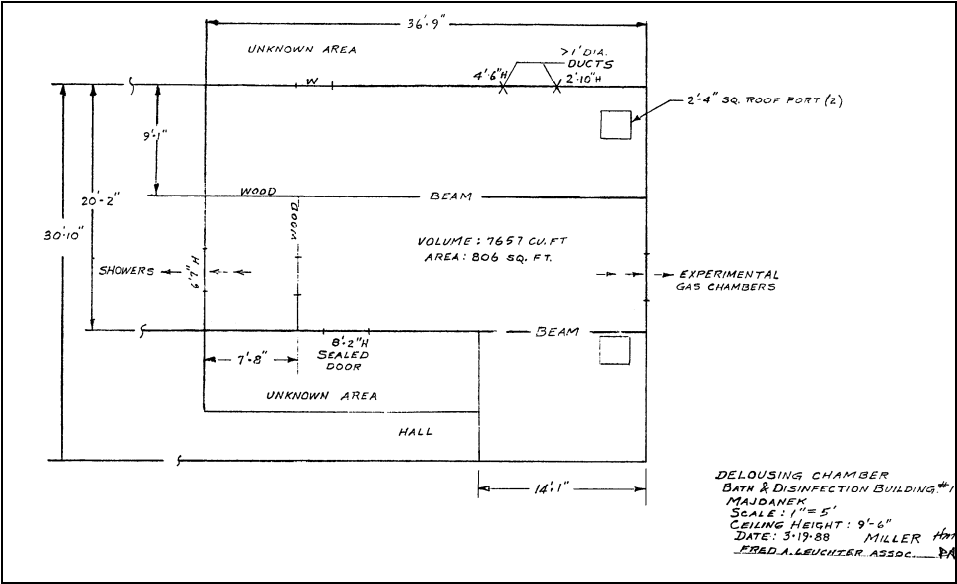
Fig. 18: Floor plan of Bath & Disinfection Building #1 at the Majdanek camp, drawn by H. Miller, Fred A. Leuchter Associates.

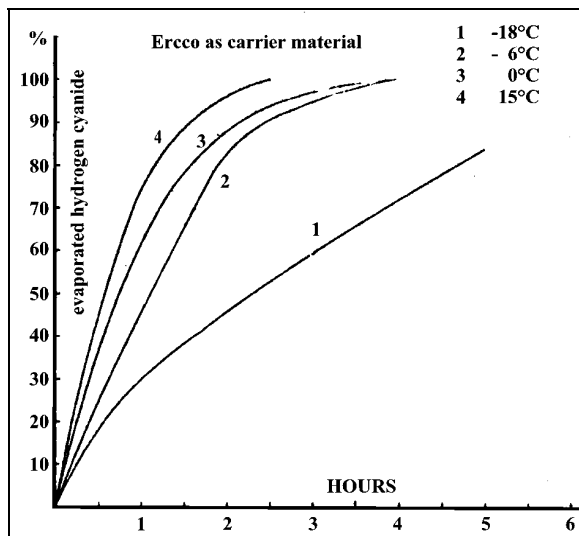
**Graph 2:** Evaporation rate of hydrogen cyanide from the Ercco carrier material (gypsum with some starch) at various temperatures and fine distribution, according to R. Irmscher/DEGESCH 1942.<sup>167</sup>

By intentional design, Zyklon B does not release its poison gas instantaneously, but rather over an extended period of time. The evaporation characteristics of this product at various temperatures are reproduced in Graph 2 as given by R. Irmscher of the DEGESCH Company in a paper published in 1942.<sup>167</sup> The evaporation is "seriously delayed" at high atmospheric humidity,

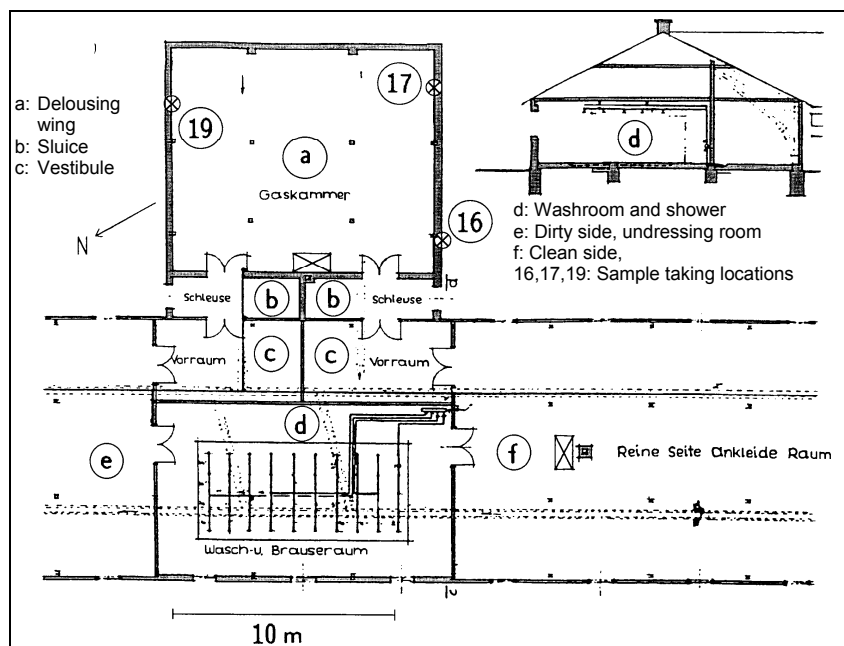
**Fig. 23:** Floor plan of the HCN disinfestation wing of building 5a before building alterations (mirror image) and BW 5b today. BW 5b sample taking locations for the Rudolf Report drawn in.<sup>179</sup>

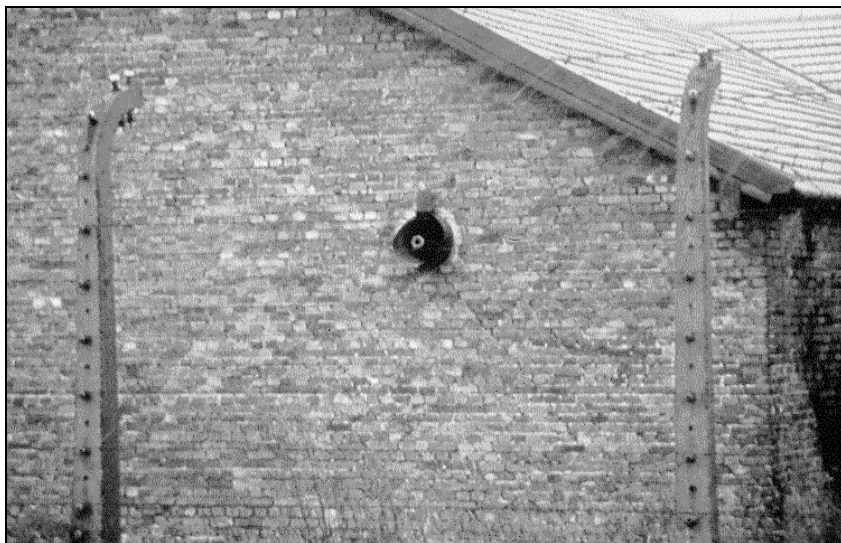
**Fig. 24:** One of the two ventilation outlets from the disinfestation wing of building BW 5b, without equipment today. The other is located on the same wall slightly to the left. The end of a water pipe installed after the war is protruding out of the hole.

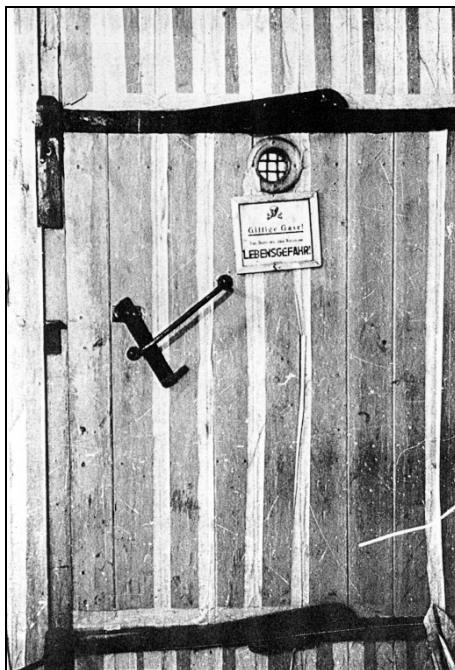
**Fig. 25:** Wooden disinfestation chamber door at Auschwitz rendered provisionally gas-tight with peephole and metal protection grid. This is what the gas-tight doors for the homicidal ‘gas chambers’ are supposed to have looked like. Note the extremely flimsy latch to lock the door.<sup>181</sup>

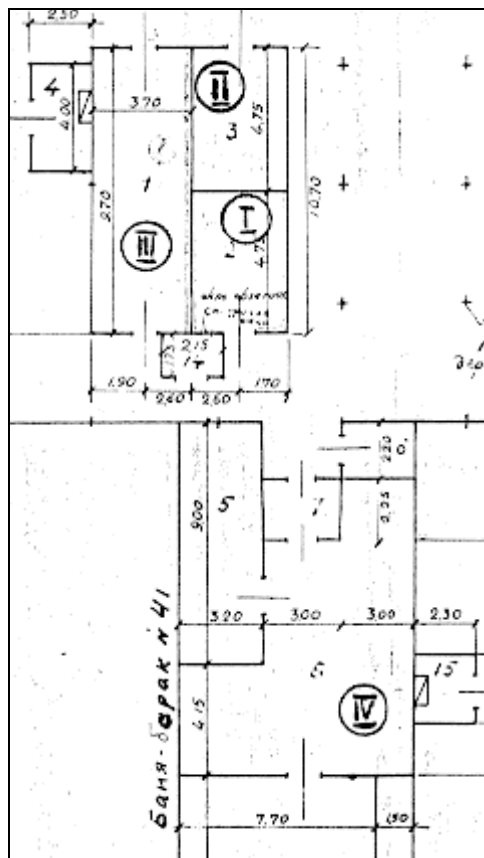
**Fig. 31:** Section of a plan of the "Bath and Disinfection Building #1," at Majdanek camp, drawn by a Polish-Soviet investigation commission. I-VI: alleged gas chambers.<sup>188</sup>

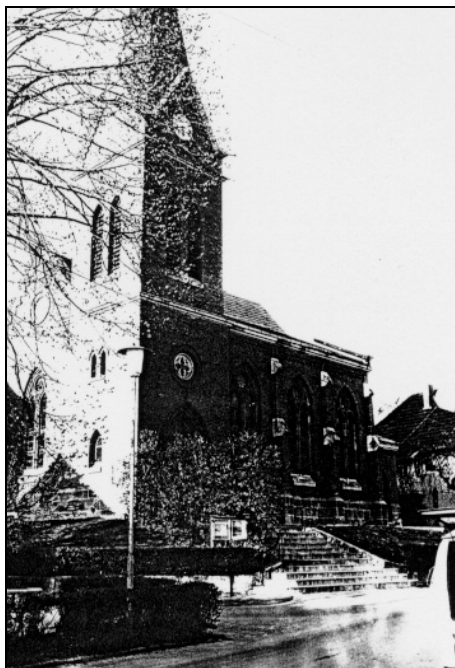
**Fig. 36:** In August 1976, the Protestant church at D-96484 Meeder-Wiesenfeld was fumigated with Zyklon B. Subsequently, blue-colored stains appeared all over the plaster (see Fig. 37).

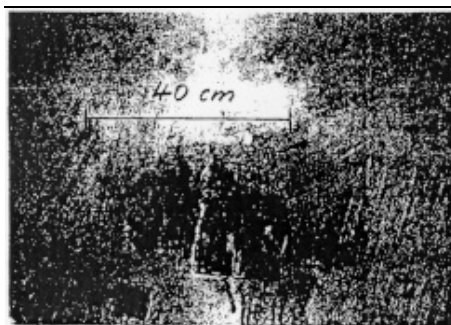
**Fig. 37:** Inky blue stains on the plaster of a church fumigated with hydrogen cyanide.

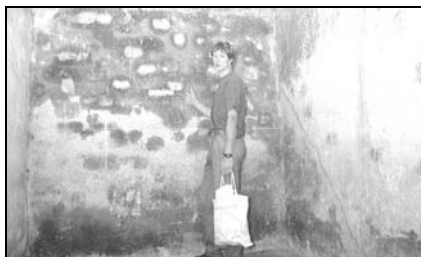
**Fig. 38:** Blue staining of the interior northwest room in the Zyklon B disinfestation wing of BW 5a in the Birkenau camp. (© Karl Philipp<sup>209</sup>)

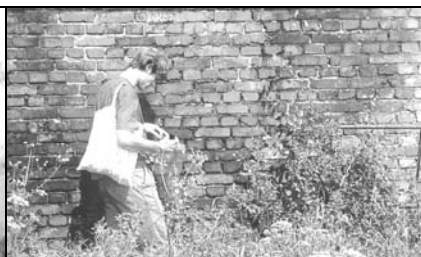
**Fig. 39:** Blue staining of the exterior southwest wall of the Zyklon B disinfestation wing of BW 5b in the Birkenau camp. (© Karl Philipp<sup>209</sup>)

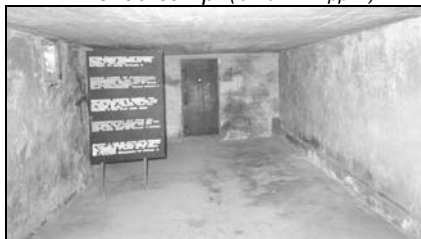
**Fig. 40:** Blue staining of the Zyklon B disinfestation installation, chamber III, of barrack 41 in Majdanek camp. (© C. Mattogno<sup>210</sup>)

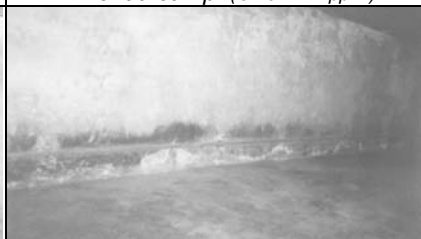
**Fig. 41:** Blue staining of the Zyklon B disinfestation installation, east wall of chamber III of barrack 41 in Majdanek camp. (© C. Mattogno<sup>210</sup>)

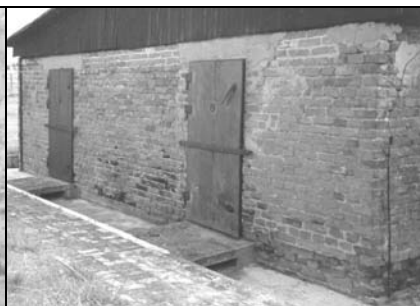
**Fig. 43:** Blue staining of the Zyklon B disinfestation installation, chambers II and III (exterior wall), of barrack 41 in Majdanek camp. (© Carlo Mattogno<sup>211</sup>)

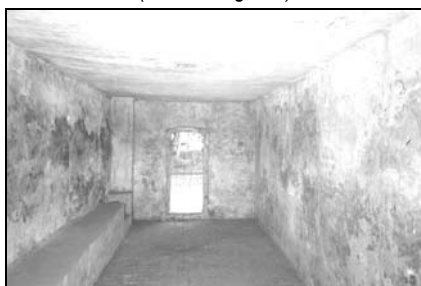
**Fig. 44:** Blue staining of the Zyklon B disinfestation chamber in Stutthof camp, interior view taken from the south door. (© Carlo Mattogno<sup>212</sup>)

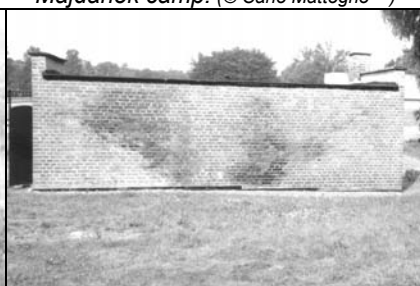
**Fig. 45:** Blue staining of the Zyklon B disinfestation chamber in Stutthof camp, east side, exterior. (© Carlo Mattogno<sup>212</sup>)

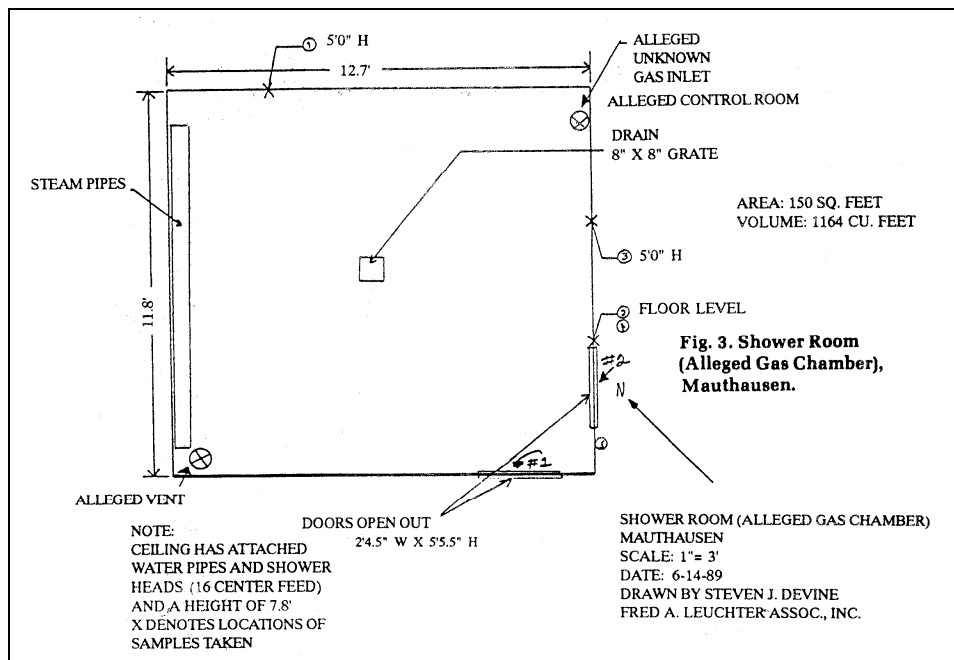
**Fig. 49:** Floor Plan of the shower (alleged gas chamber) at Mauthausen camp, Austria.  
Encircled X denote locations of wall samples taken.

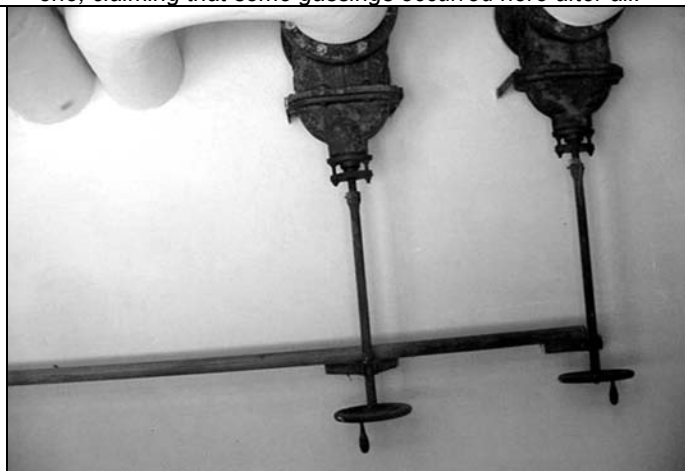
**Fig. 51:** Heavy insulated hot water (or steam?) pipes in the room behind the alleged gas chamber of Dachau camp, leading into the space above the current room.<sup>1</sup>

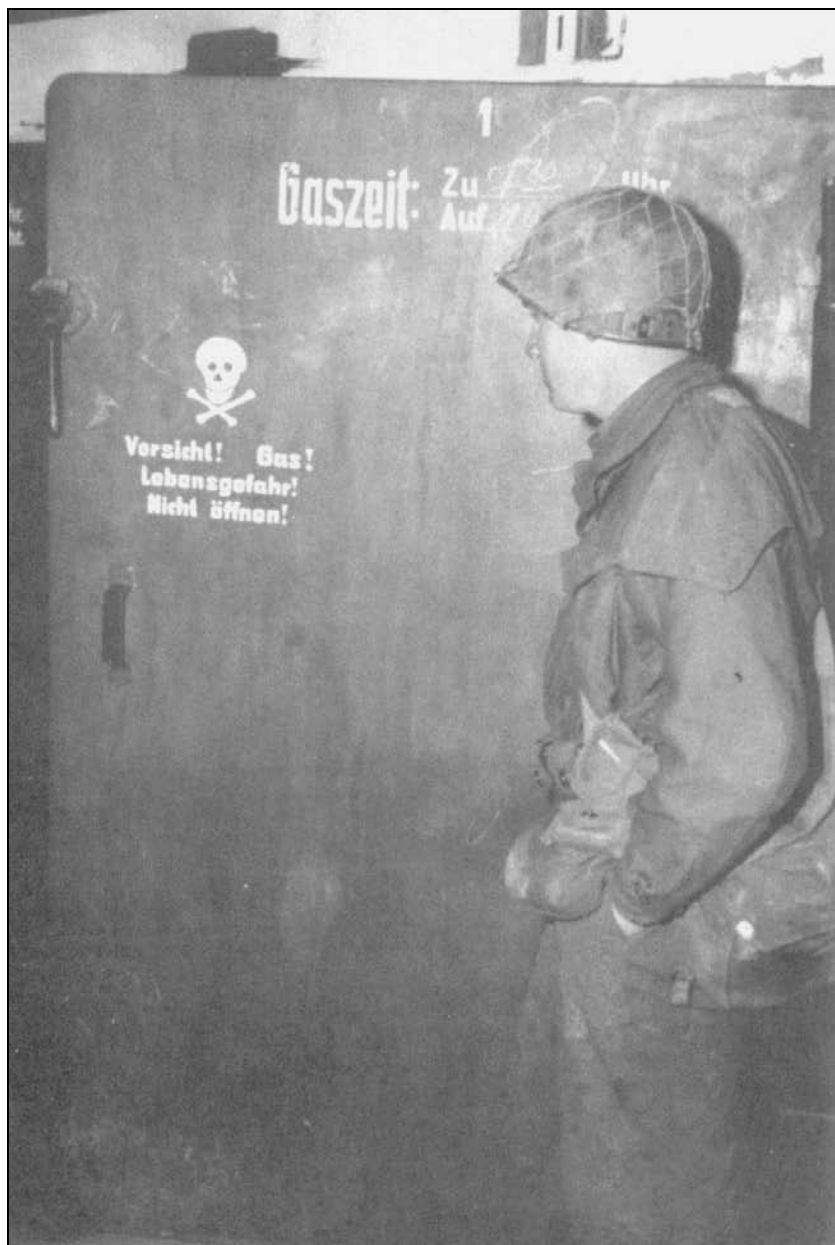
**Fig. 52:** Door of disinfestation chamber at Dachau. The inscriptions on the door specify that the chamber was last used from 7:30 to 10 in the morning. The warning reads "Caution! Gas! Life danger! Do not open!" The U.S. Army caption for this photograph declares deceptively: "Gas chambers, conveniently located to the crematory, are examined by a soldier of the U.S. Seventh Army. These chambers were used by Nazi guards for killing prisoners of the infamous Dachau concentration camp."<sup>2</sup>

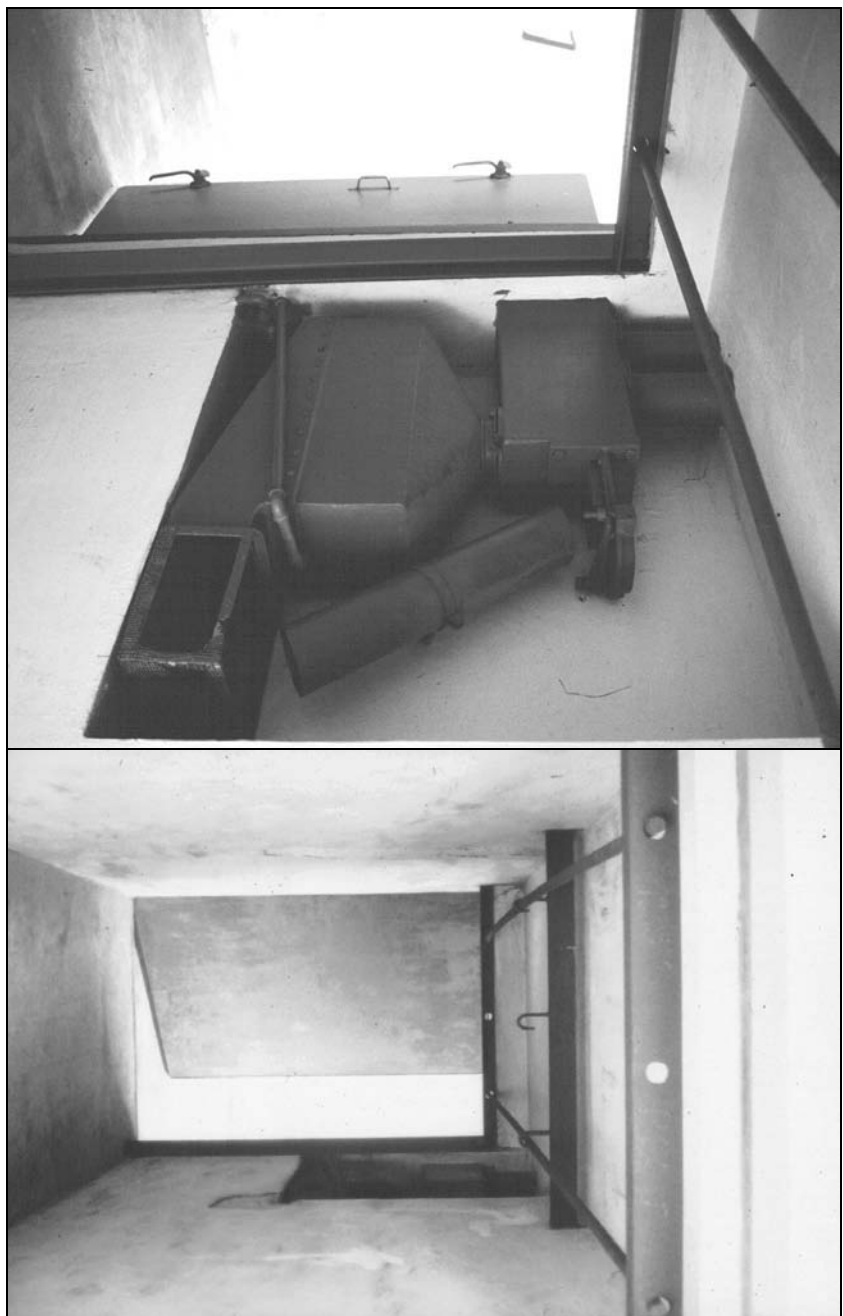
**Fig. 57 & 58:** Interior of disinfestation chamber at Dachau. left: DEGESCH Kreislaufanlage (circulation device); right: look through the chamber.<sup>5</sup>

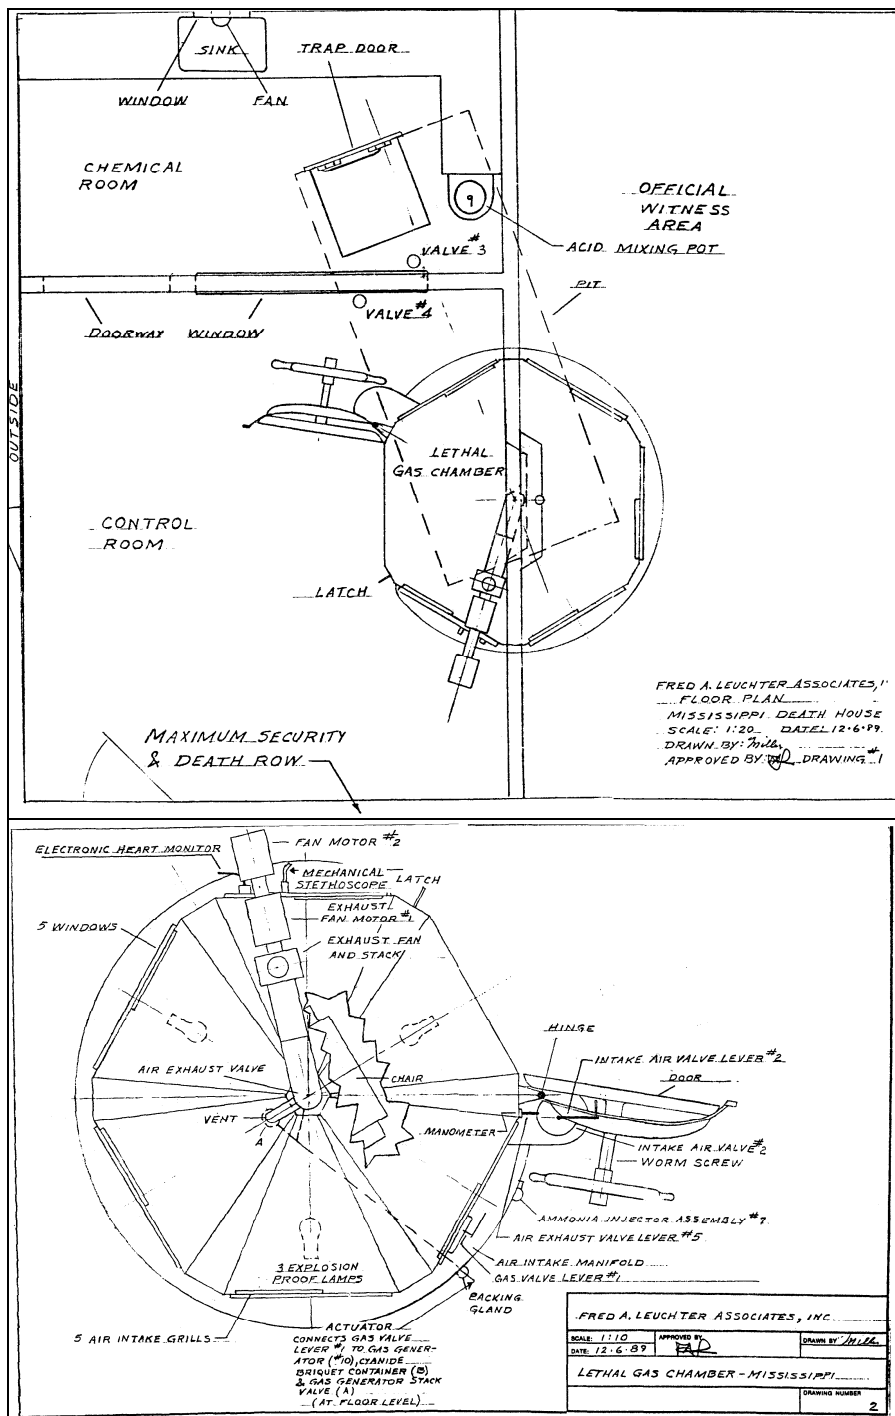
Fig 69 &amp; 70: Technical drawings of the Parchman (MS) execution gas chamber.

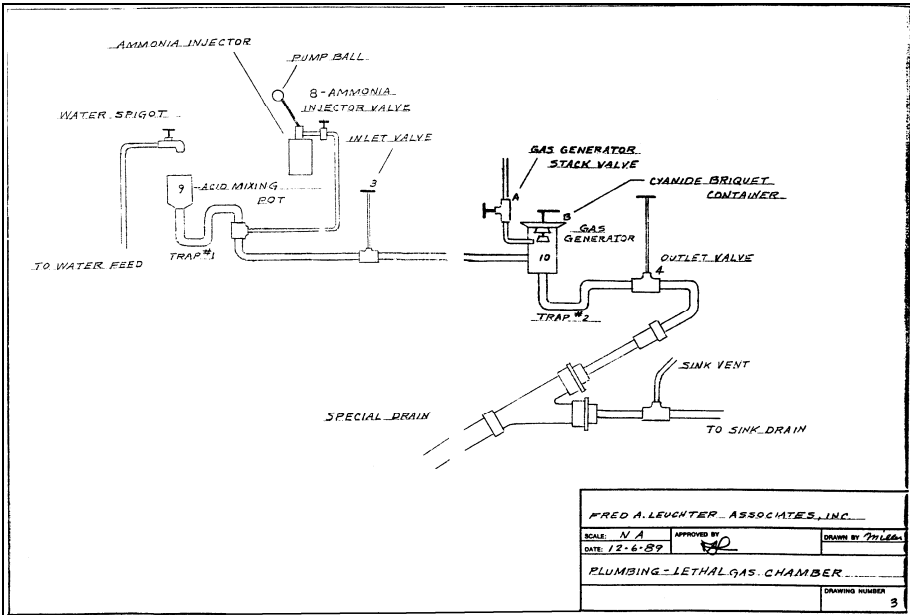
Fig 71: Technical drawing of gas generator of the Parchman (MS) execution gas chamber.

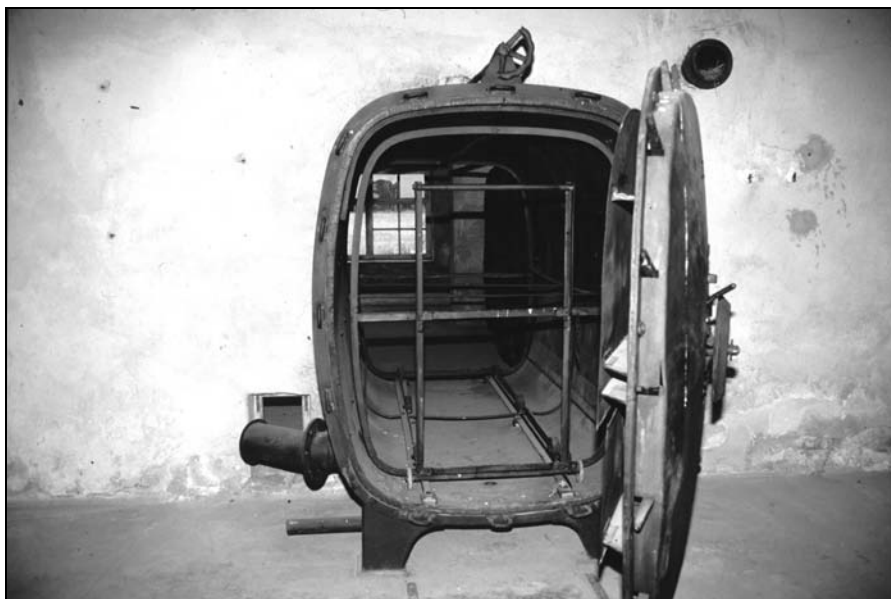
**Fig. 78:** Hot air disinfestation autoclave in the so-called “Zentralsauna” in Auschwitz Birkenau with similar doors as used for the U.S. execution gas chambers. Although the German camp authorities had the technology required for constructing execution gas chambers, they did not use it. They used this technology to save the lives of their prisoners instead.

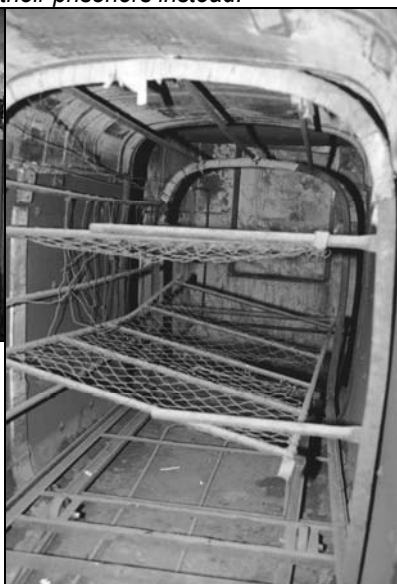
**Fig. 80:** Inside of the hot air disinfestation autoclave in Mauthausen with rusting cloth racks.

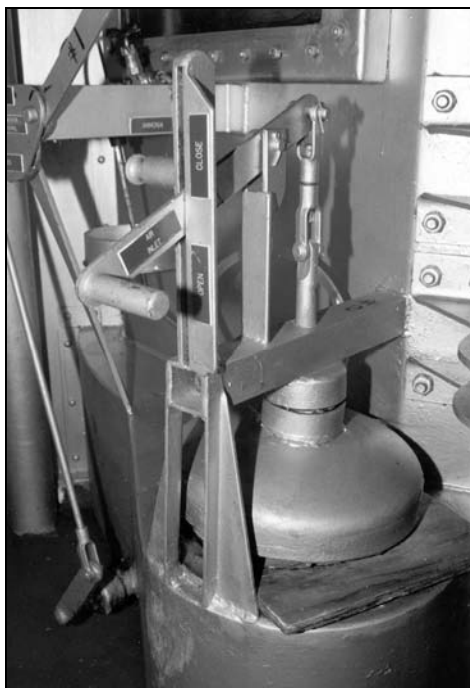
**Fig. 84:** Closeup of fresh air intake of gas chamber.

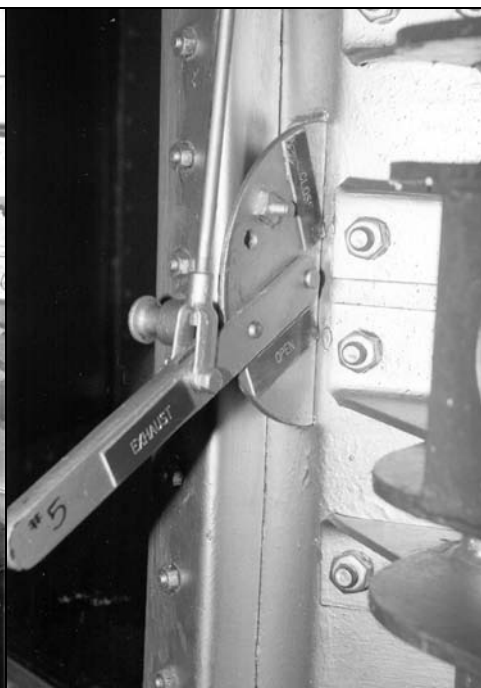
**Fig. 85:** Closeup of lever used to open and close exhaust stack.

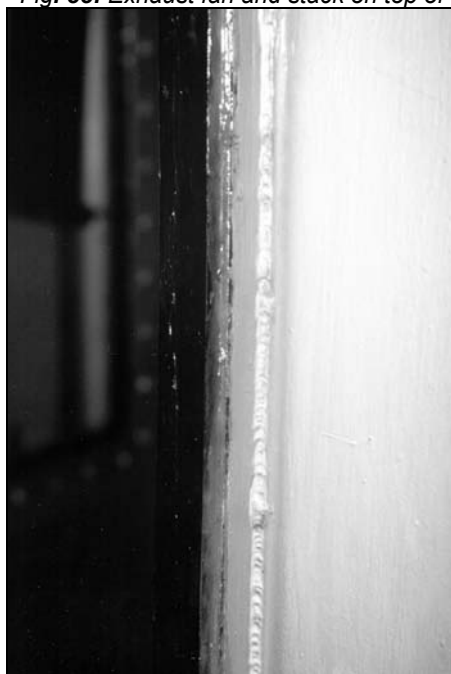
**Fig. 90:** Closeup of rubber seal around gas chamber door, also covered in vaseline when in use.

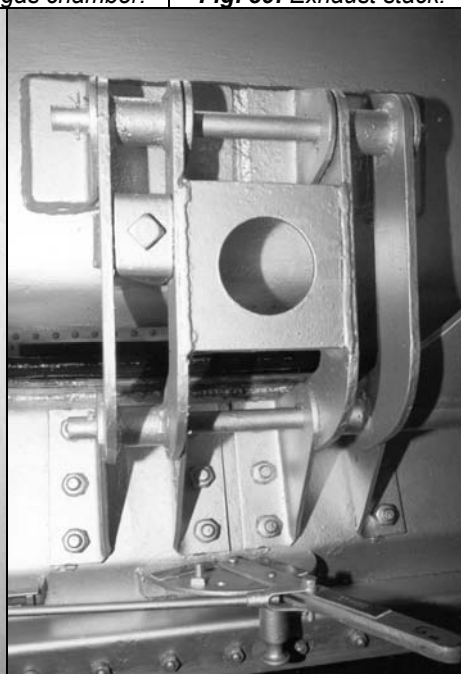
**Fig. 91:** Closeup of gas chamber door hinge.

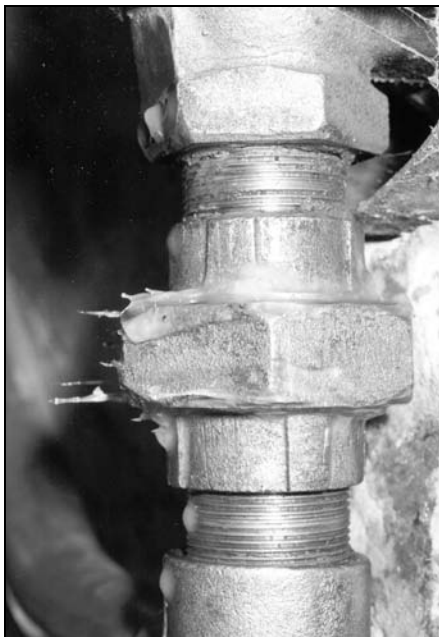
**Fig. 92:** Closeup of plumbing underneath the gas chamber covered in vaseline to indicate leaks.

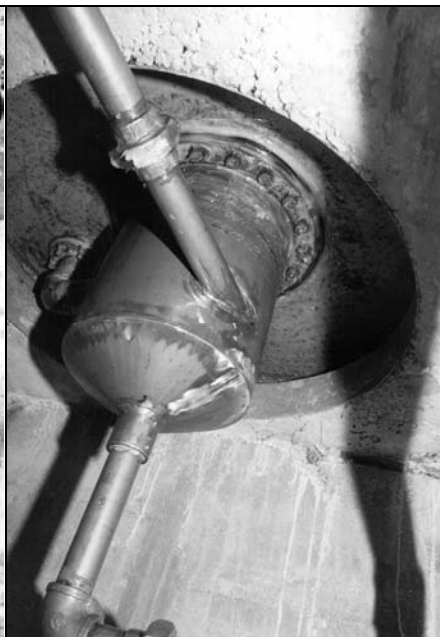
**Fig. 93:** View of stainless steel plumbing and chemical container directly under seat in gas chamber.

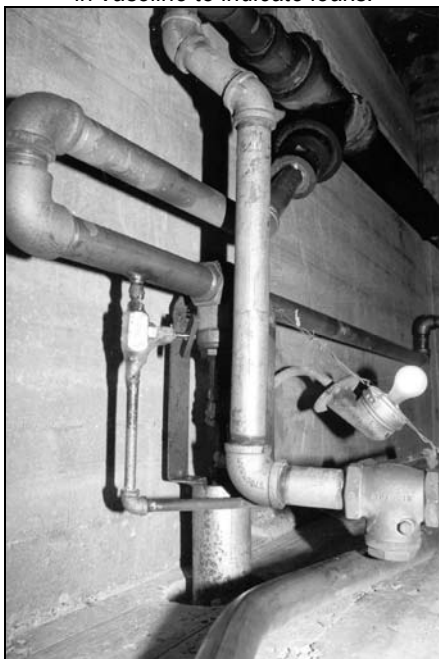
**Fig. 94:** Portion of plumbing and sewage system connecting chemical room to gas chamber.

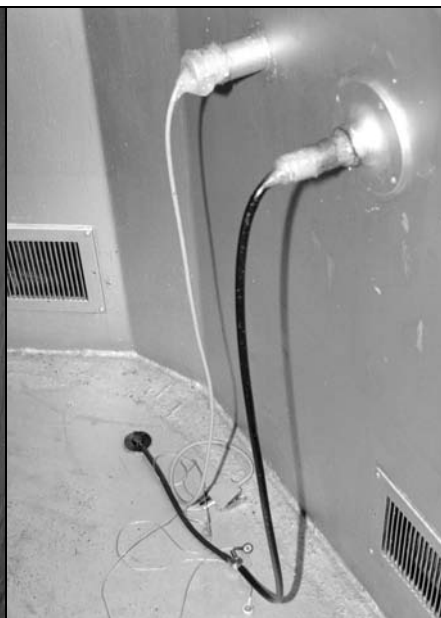
**Fig. 97:** Inside gas chamber where stethoscope and other body monitoring line enter. They are covered in vaseline to indicate leaks. Fresh air vents on the walls close to the floor.

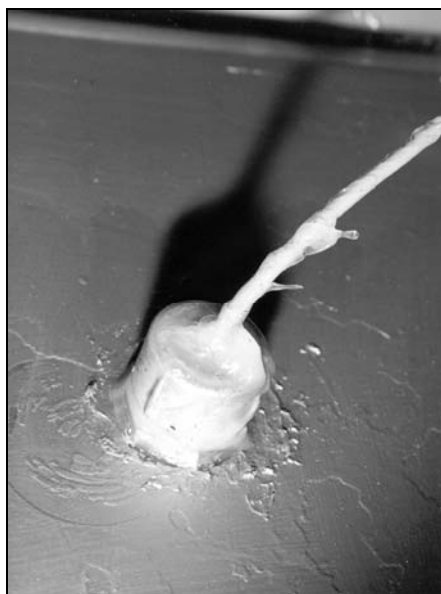
**Fig. 98:** Closeup of where monitoring line enters chamber also coated in vaseline.
